# ***SFHS Meeting Coral Springs, FL May 8th, 2013***

## **HERBERT HOOVER DIKE REHABILITATION “THE IMPORTANCE OF DAM SAFETY IN SOUTH FLORIDA”**

# *Installation of Deep Cutoff Wall Using the Cutter Soil Mixing Method*

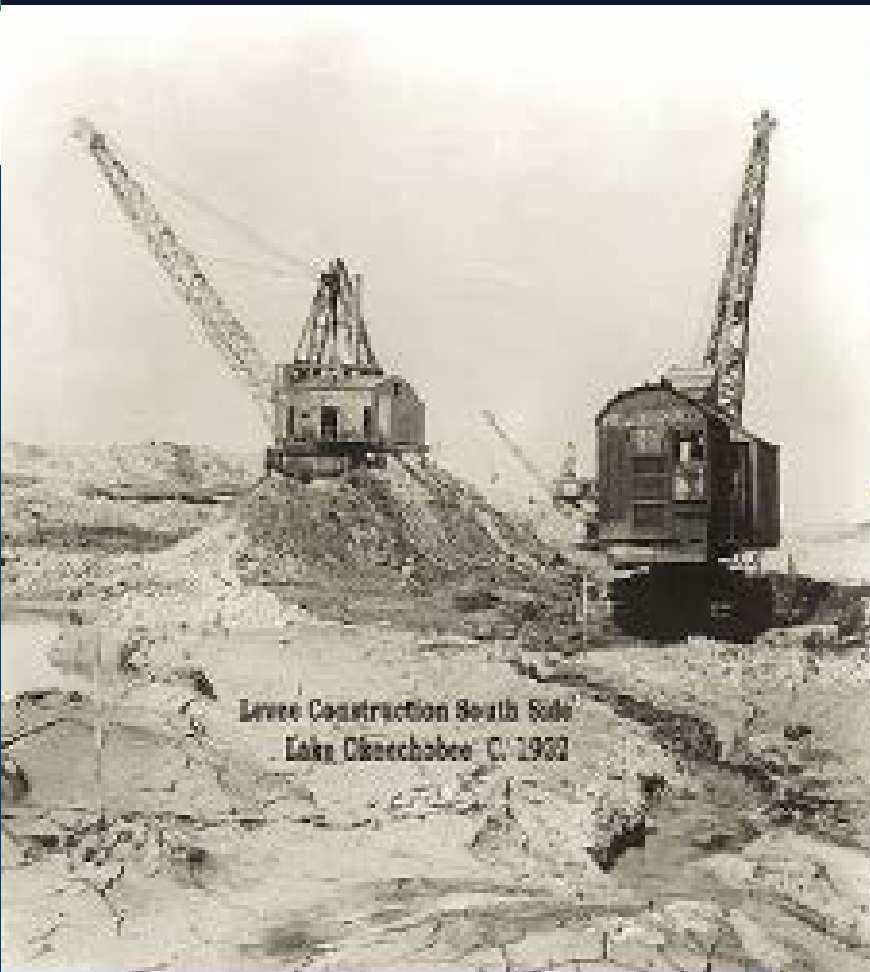
Levee Construction South Side  
Lake Okeechobee C. 1933

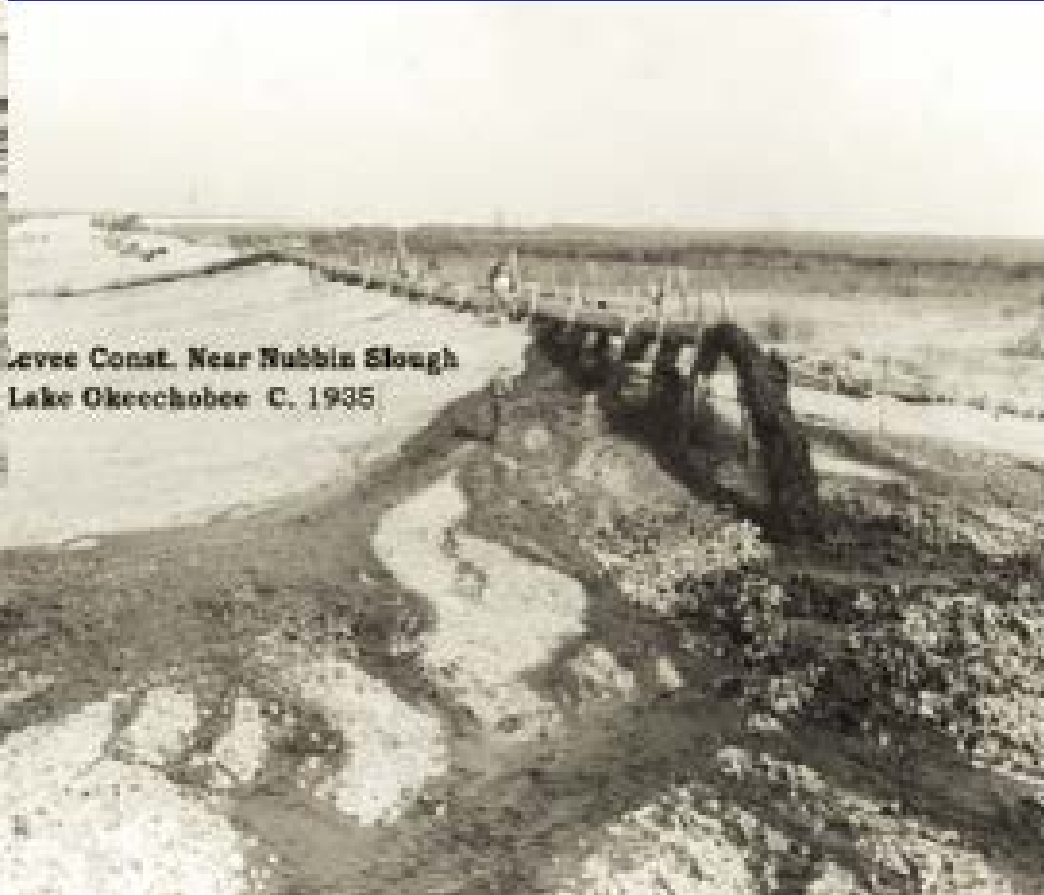
Levee Const. Near Rubbin Slough  
Lake Okeechobee C. 1935

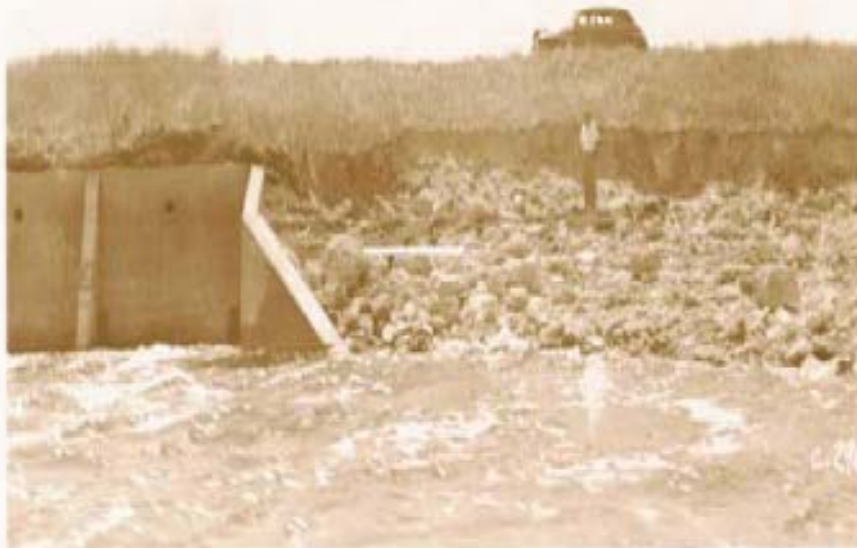
FIG. 2  
SERIOUS EROSION ON UNPROTECTED LEVEE FACE

LEVEE EROSION ABOUT WIDWAY BETWEEN  
HURRICANE GATE STRUCTURES NOS. 2 AND  
3, CAUSED BY THE HURRICANE OF  
SEPTEMBER 17, 1947.

LEVEE EROSION-1947 HURRICANE

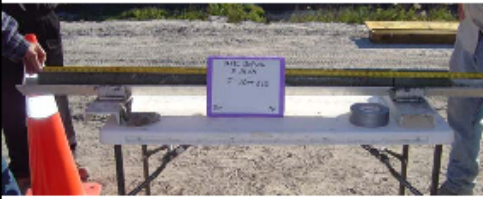
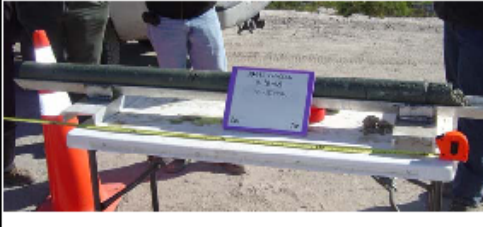
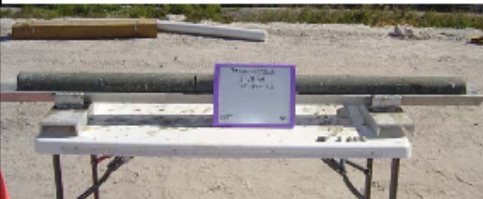
WILLIAMS EARTH SCIENCES, INC.		VERIFICATION BORING LOG		DIVISION Jacksonville		INSTALLATION		SHEET 1 OF 3 SHEETS	
PROJECT Herbert Hoover Dike Demonstration section 1504+50.6				SIZE & TYPE OF BIT Diamond Stepbit Bottom Dish					
BORING DESIGNATION 1504506				TYPE OF DRILL RIG CME 650					
LOCATION COORDINATES X= -1.9 Y= -0.3				TOTAL NUMBER CORE BOXES 5					
DRILLING AGENCY Williams Earth Sciences				ELEVATION GROUND WATER 14.33 (assumed based on reported lake level)					
CONTRACTOR FILE NO.				DATE BORING START 11/18/06 COMPLETED 11/18/06					
DEPTH OF BORING (ft) 55				ELEVATION TOP OF BORING 35.14					
NAME OF DRILLER Jim Spoon				MAX SAMPLE LENGTH (in) 60					
				CORE SAMPLE DIAMETER (in) 3.3					
				BOREHOLE LOGGER: Gabrielle Enos					
ELEV. DEPTH	MATERIAL DESCRIPTIONS & NOTES	BOX #	GEAR PRESS. (psi)	RPM	TIME (min:sec)	REC (ft)	ROD (ft)	Q <sub>u</sub> (psi)	PICTURE

35.1 0	No samples collected in upper 5 feet. Top of wall begins at 5 ft bls								
30.1 5	Dark greenish-grey cementitious soil with shell inclusions	2nd	200	60	0.2	100	95

25.1 10	Dark greenish-grey cementitious soil with shell inclusions  hard drilling at 3 feet into run	2nd	200	60	8:24	100	100

20.1 15	Dark greenish-grey cementitious soil with shell inclusions  UCC Sample at 17-18 ft bls	2nd	200	60	3:54	100	767.1 844.6

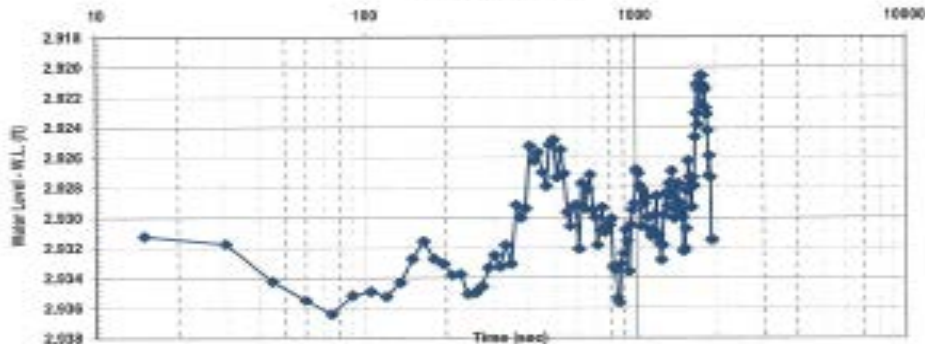
Falling Head Test

## REPORT OF FALLING HEAD PERMEABILITY TEST

Project Name: HHD-Reach 1 Contractor: Bauer  
 Hole Number: 1504506 Borehole Logger: Williams  
 Station: 1504+50.6 Driller: Williams  
 Date: 11/21/2008

Elevation of Ground Surface in NAVD88 ( $H_g$ ): 35.14 ft  
 Elevation of Groundwater ( $H_w$ ): 14.41 ft  
 (Assume groundwater level equals water level of Lake)

Height of Standpipe Above Ground ( $H_s$ ): 0.35 ft  
 Depth to Bottom of Packer ( $L_1$ ): 0 ft  
 Depth to Bottom of Tested Zone ( $L_2$ ): 56.65 ft  
 $L = (L_2 - L_1) \times 30.48 = \underline{1726.652}$  cm

Borehole Diameter ( $D$ ): 4.8 in.  $\times 2.54 = \underline{12.192}$  cm  
 Standpipe Diameter ( $d_s$ ): 4.8 in.  $\times 2.54 = \underline{12.192}$  cm

Test Start Time: 10:11:30 End Time: 10:49:30  
 Total Test Time (minutes): 32.25  $k_p = \underline{4.4E-10}$  cm/s (average)  
 $k_p = \underline{4.4E-10}$  cm/s (between begin and end times)

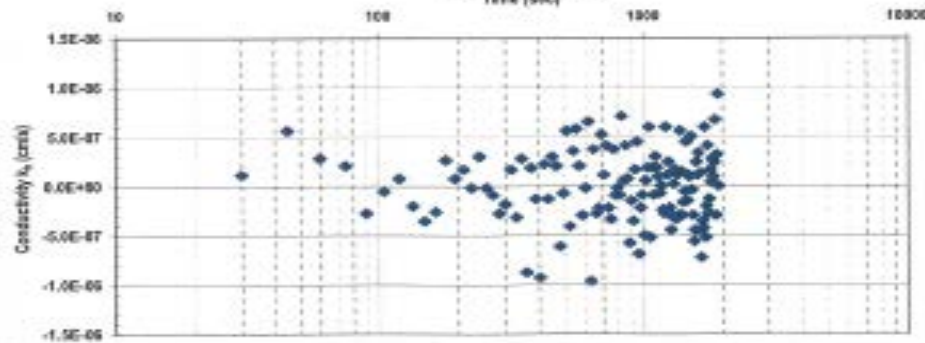
Falling Head Test

❖ Open Hole  
 Falling Head  
 Permeability  
 Tests

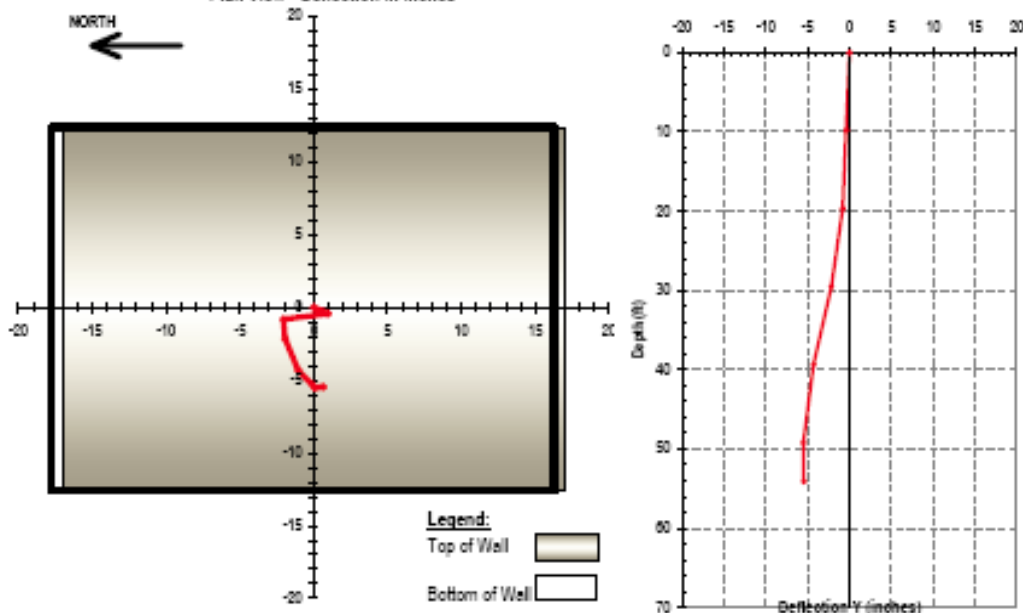
# Inclinometer Graphic Results

Plan View - Deflection in inches

Project: Herbert Hoover Dike - Reach 1, Task 2  
 Boring: Panel 1504506, uphole readings  
 Source: rd Settings\swes\My Documents\P1504506uphole.ASC  
 Inspector: -

Wall End Deviation: -0.750 inches along wall length  
 -0.120 inches along wall width  
 $\alpha$ : 90 degrees  Built-in Boretrack Data  
 Wall compass reading  $\beta$ : 180 degrees (From 0 to 360)  
 Hole Depth: 55.0 ft  
 Average Deflection: 0.9 degrees X: 0.08 inches along length  
 Max Deflection: 5.51 inches Y: -5.51 inches along width

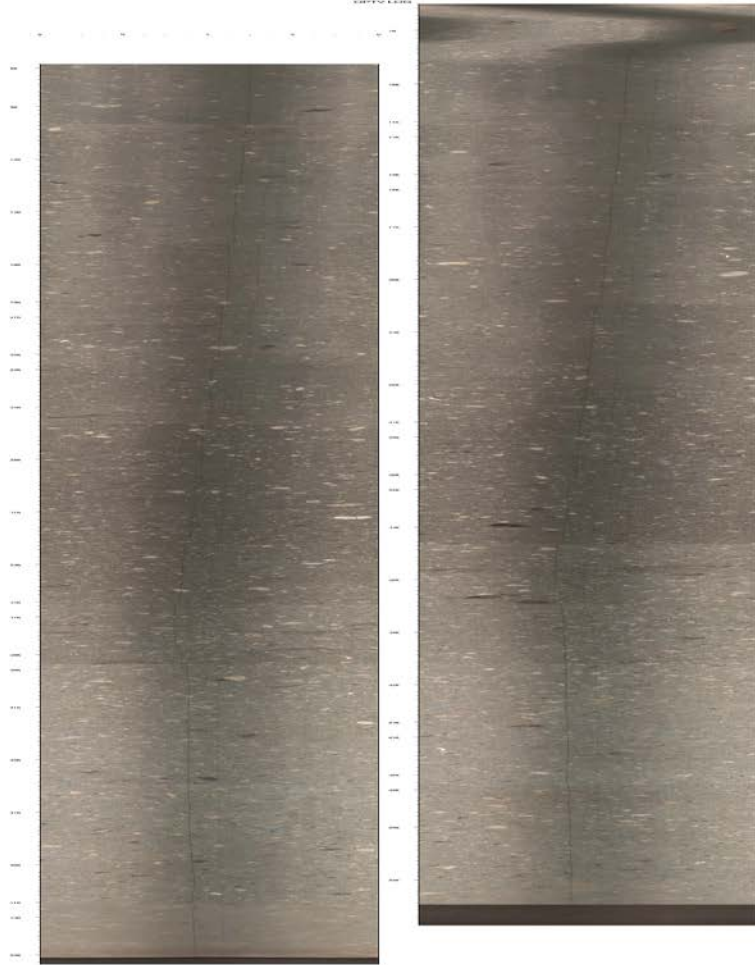
- ❖ Downhole Video Log
- ❖ 360 degree view
